VEHICLE & CUSTOMER SUMMARY

| Registration No | AEY-860 | Make & Model | Toyota Yaris Ativ 1.3 CVT | Year / Colour | 2021 / White |
| Chassis / VIN | NSP150R7020725 | Engine No | 1NR2A33749 | Mileage | 31,804 KM |

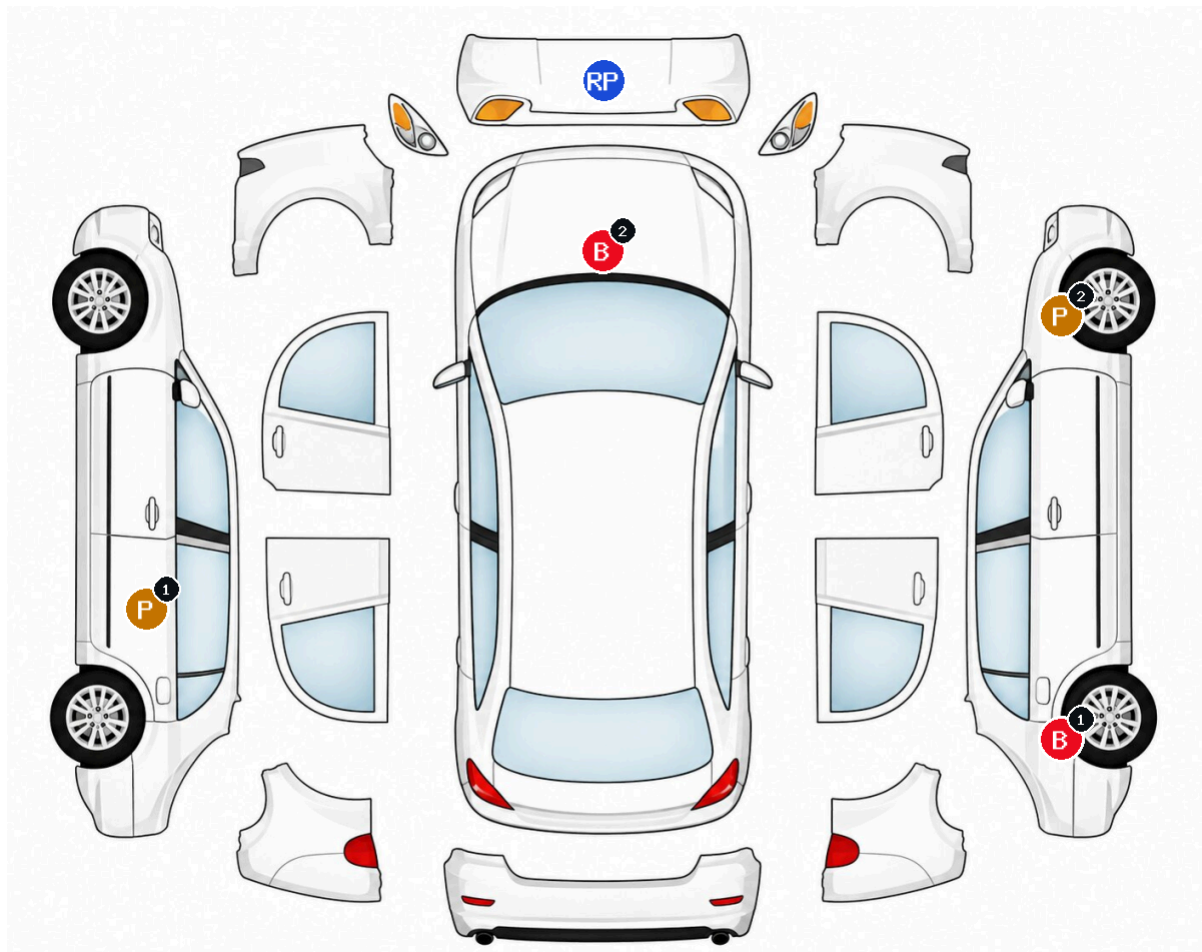
## VEHICLE DAMAGE MAP

| # | Panel / Area | View | Code | Action | Officer Remarks |
|---|---|---|---|---|---|
| 1 | Front Fender (Right) | Right | P2 | Repair | Repainted with dry dents, filler detected |
| 2 | Bonnet / Hood | Top | B2 | Repair | Medium dent near right edge |
| 3 | Front Bumper | Front | RP | None | Full repaint detected via paint depth gauge |
| 4 | Rear Fender (Right) | Right | B1 | Repair | Small dent above wheel arch |
| 5 | Side Spoiler / Skirt (Left) | Left | P1 | Repair | Scratch on lower edge |
| 6 | Head Lamp (Right) | Front | X1 | Replace | Lens crack — light broken |
